**Flood Control Project Maintenance
Levee Inspections****LMA District Cover Sheet****Spring 2012 Levee Inspection Results****Reclamation District No. 2092 Dos Rios**

Spring 2012 Levee Inspection Results

Reclamation District No. 2092 Dos Rios

Waterway			Bank	Unit Miles
Unit No. 01 San Joaquin River			Right	3.76
	Spring (March - May)	Summer (June - August)	(September - November) Fall	Winter (December - February)
Unit Maintenance Rating (Fall Only)				
Date of Inspection	5/17/2012 - 5/17/2012			
DWR Inspector	Pavel Kazi			
Accompanied By

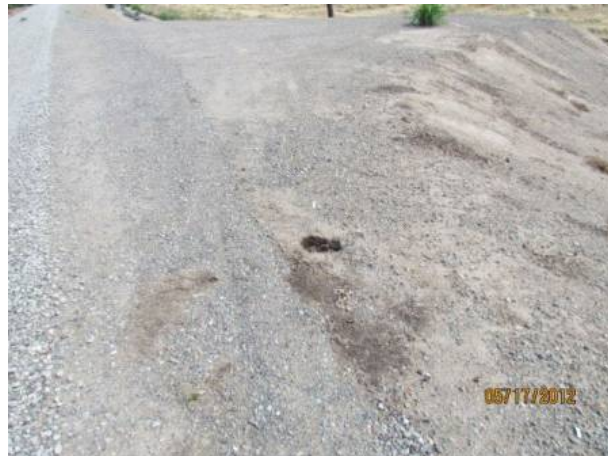
Levee Mile Report Line	9
Start Levee Mile	0.88
End Levee Mile	0.88
Location	Land Side
Category	Earthen Levee
Item	Animal Control

A rodent hole was found on the landside of the levee looking downstream.

9	0.88	0.88	Earthen Levee	Animal Control	LS Ma	A3 : No rodents visible, but rodent burrows visible; need to backfill and compact or grout burrows.	37.595762 ° -121.168187 °	37.595762 ° -121.168187 °	6 Y
DWR ID: DWR_RD2092_01_s_2012_6									
10	1.34	1.57	Earthen Levee	Encroachments	LS Ma	AD : Agricultural Ditch	37.590479 ° -121.163844 °	37.587758 ° -121.162349 °	7 Y
DWR ID: DWR_RD2092_01_s_2012_7									
11	1.34	1.34	Earthen Levee	Encroachments	LS Ma	PI : Pipe Inspector Comments: A sand boil appeared on the landside toe of the levee because of an underground pipe leakage.	37.590467 ° -121.163822 °	37.590467 ° -121.163822 °	10 Y
DWR ID: DWR_RD2092_01_s_2012_10									
12	1.34	1.34	Earthen Levee	Animal Control	LS Ma	A3 : No rodents visible, but rodent burrows visible; need to backfill and compact or grout burrows.	37.590458 ° -121.163798 °	37.590458 ° -121.163798 °	9
DWR ID: DWR_RD2092_01_s_2012_9

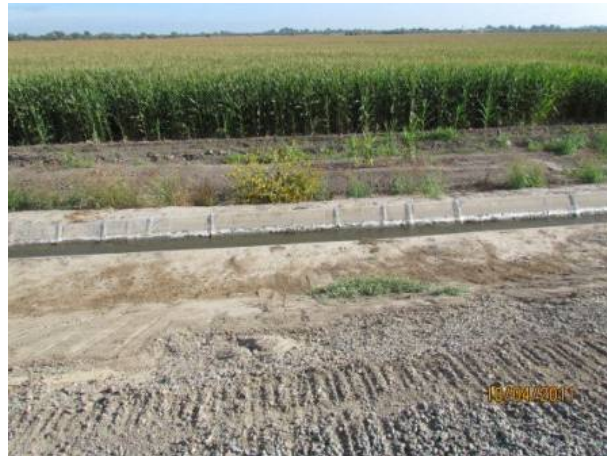
Levee Mile Report Line	10
Start Levee Mile	1.34
End Levee Mile	1.57
Location	Land Side
Category	Earthen Levee
Item	Encroachments

An agricultural ditch was found on the toe of the landside of the levee looking upstream.

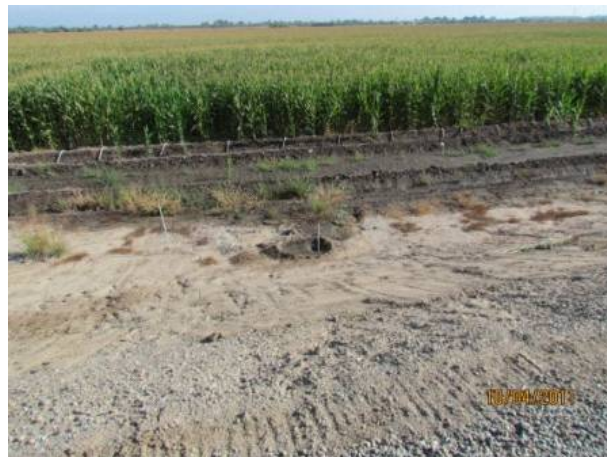
Levee Mile Report Line	11
Start Levee Mile	1.34
End Levee Mile	1.34
Location	Land Side
Category	Earthen Levee
Item	Encroachments

A sand boil was found on the landside of the levee. It was caused by a pipe leak couple of feet below the boil location. LMA was notified to repair it as soon as possible. The picture was taken from the crown looking upstream.

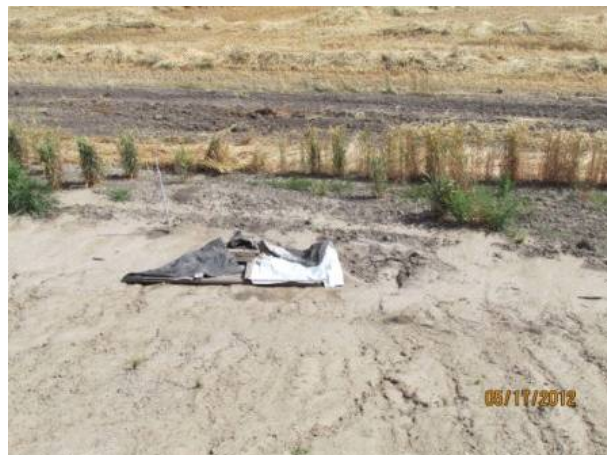
Levee Mile Report Line	11
Start Levee Mile	1.34
End Levee Mile	1.34
Location	Land Side
Category	Earthen Levee
Item	Encroachments

During spring inspection 2012, the sand boil was not active but materials were present on the landside toe of the levee. The sand boil occurred due to an underground irrigation pipe leakage. The picture was taken from the crown looking toward the toe of the levee.

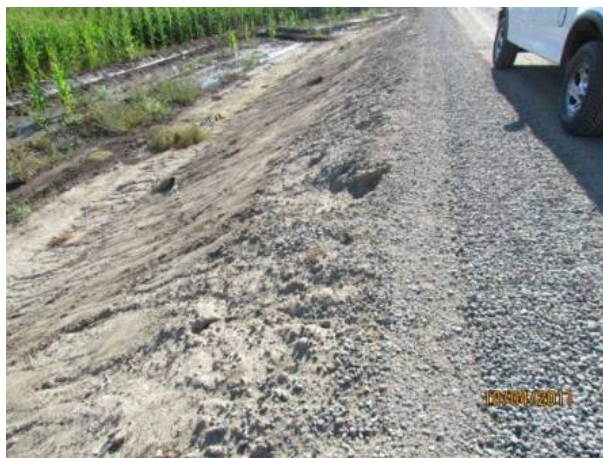
Levee Mile Report Line	13
Start Levee Mile	1.36
End Levee Mile	1.36
Location	Land Side
Category	Earthen Levee
Item	Slope Stability

Slope instability was found on the landside slope of the levee looking upstream.

13	1.36	1.36	Earthen Levee	Slope Stability	LS Ma	S1 : Repair slope instability.	37.590341 ° -121.163549 °	37.590341 ° -121.163549 °	11 Y
DWR ID: DWR_RD2092_01_s_2012_11									
14	1.47	1.47	Earthen Levee	Animal Control	LS Ma	A3 : No rodents visible, but rodent burrows visible; need to backfill and compact or grout burrows.	37.589053 ° -121.162168 °	37.589053 ° -121.162168 °	13 Y
DWR ID: DWR_RD2092_01_s_2012_13

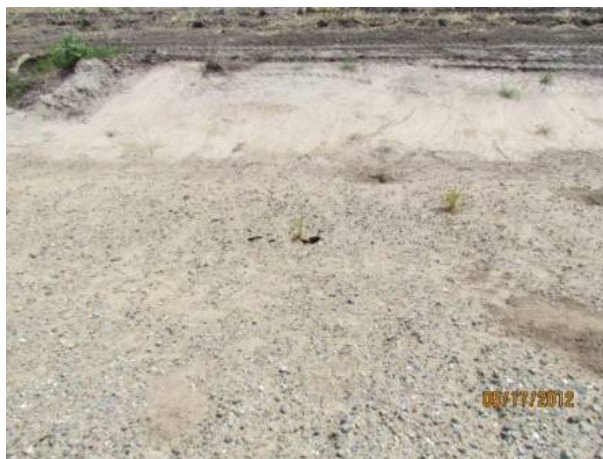
Levee Mile Report Line	14
Start Levee Mile	1.47
End Levee Mile	1.47
Location	Land Side
Category	Earthen Levee
Item	Animal Control

Animal holes were found on the landside of the levee looking upstream.

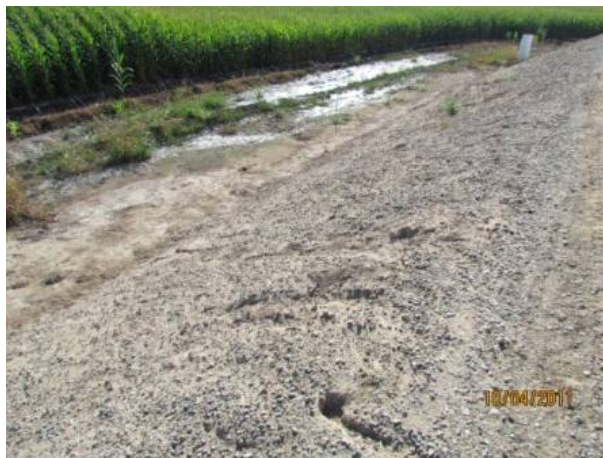
Levee Mile Report Line	15
Start Levee Mile	1.47
End Levee Mile	1.47
Location	Land Side
Category	Earthen Levee
Item	Slope Stability

Slope instability was found on the landside of the levee looking upstream.

LMR No.	Levee Mile		Category	Item	Location	Rating	Action/Comment	GPS Latitude/Longitude		Issue No.
	Start	End						Start	End	
15	1.47	1.47	Earthen Levee	Slope Stability	LS	M Ma	S1 : Repair slope instability.	37.589061 ° -121.162168 °	37.589061 ° -121.162168 °	25 Y
DWR ID: DWR_RD2092_01_s_2012_25										
16	1.53	1.53	Earthen Levee	Animal Control	LS	M Ma	A3 : No rodents visible, but rodent burrows visible; need to backfill and compact or grout burrows.	37.588375 ° -121.162084 °	37.588375 ° -121.162084 °	12 Y
DWR ID: DWR_RD2092_01_s_2012_12										
17	1.58	1.58	Earthen Levee	Animal Control	LS	A Ma	A3 : No rodents visible, but rodent burrows visible; need to backfill and compact or grout burrows.	37.587657 ° -121.162393 °	37.587657 ° -121.162393 °	23 Y
DWR ID: DWR_RD2092_01_s_2012_23										
18	1.59	1.87	Earthen Levee	Encroachments	WS	M En	AD : Agricultural Ditch	37.587575 ° -121.162454 °	37.584057 ° -121.162387 °	8 Y

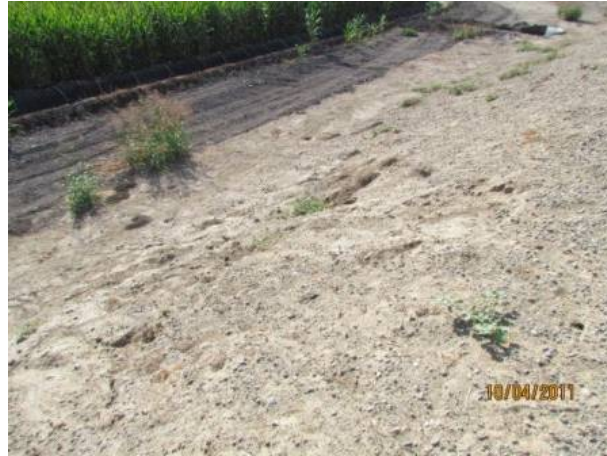
Levee Mile Report Line	16
Start Levee Mile	1.53
End Levee Mile	1.53
Location	Land Side
Category	Earthen Levee
Item	Animal Control
Rodent holes were found on the landside of the levee looking upstream.	
pkazi_s_20120305_742.jpg

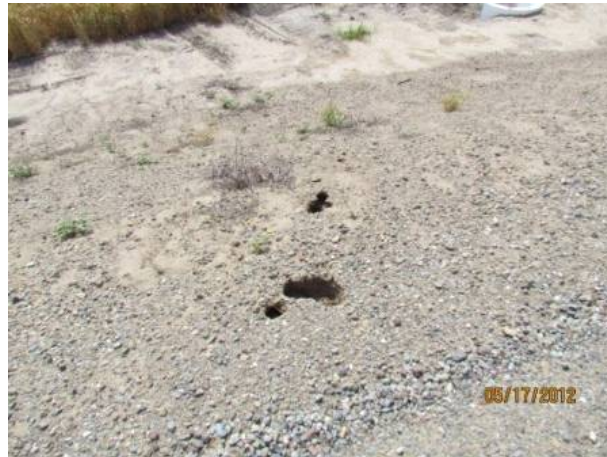
Levee Mile Report Line	16
Start Levee Mile	1.53
End Levee Mile	1.53
Location	Land Side
Category	Earthen Levee
Item	Animal Control
Rodent holes were found on the landside slope of the levee looking upstream.	
pkazi_s_20120518_064.jpg

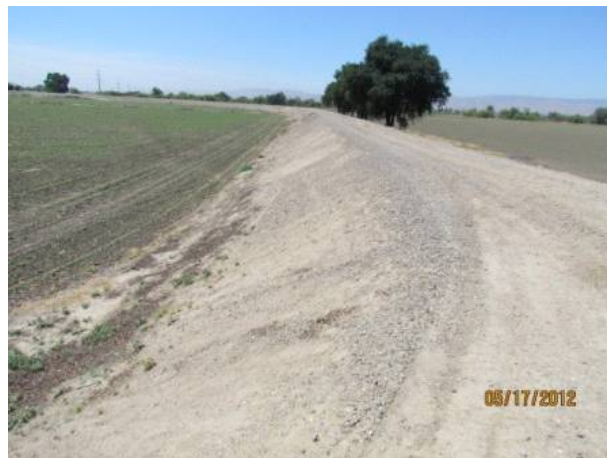
Levee Mile Report Line	17
Start Levee Mile	1.58
End Levee Mile	1.58
Location	Land Side
Category	Earthen Levee
Item	Animal Control
Rodent holes were repaired by the LMA on the landside slope of the levee looking upstream.	
pkazi_s_20120518_067.jpg

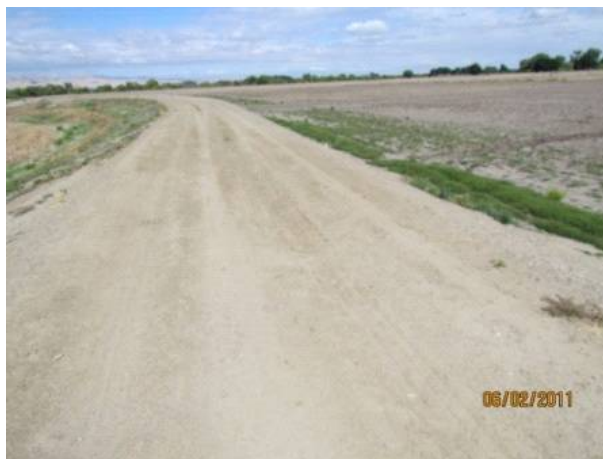
Levee Mile Report Line	22
Start Levee Mile	2.02
End Levee Mile	2.02
Location	Crown
Category	Earthen Levee
Item	Crown Surface / Depressions / Rutting

Crown depression was found due to vehicular traffic. The picture was taken from crown looking downstream.

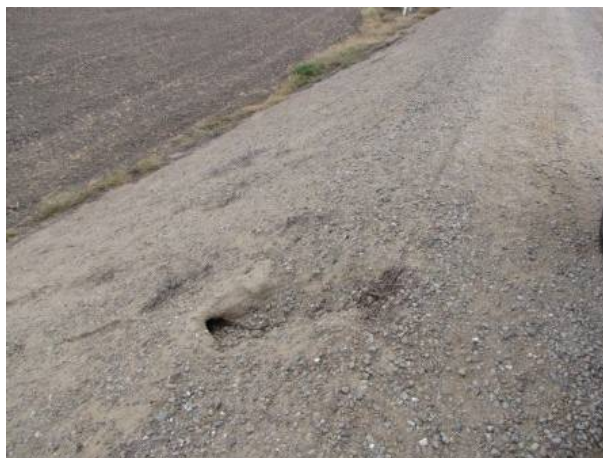
Levee Mile Report Line	23
Start Levee Mile	2.07
End Levee Mile	2.07
Location	Land Side
Category	Earthen Levee
Item	Animal Control

View of rodent holes in the landward shoulder looking upstream.

DWR ID: DWR_RD2092_01_s_2012_27										
23	2.07	2.07	Earthen Levee	Animal Control	LS	M Ma	A3 : No rodents visible, but rodent burrows visible; need to backfill and compact or grout burrows.	37.584295 ° -121.158809 °	37.584295 ° -121.158809 °	971 Y
DWR ID: DWR_RD2092_01_s_2012_971										
24	2.09	2.09	Earthen Levee	Animal Control	LS	A Ma	A3 : No rodents visible, but rodent burrows visible; need to backfill and compact or grout burrows.	37.584226 ° -121.158437 °	37.584226 ° -121.158437 °	22 Y
DWR ID: DWR_RD2092_01_s_2012_22										
25	2.10	2.10	Earthen Levee	Animal Control	LS	C Ma	A3 : No rodents visible, but rodent burrows visible; need to backfill and compact or grout burrows.	37.584200 ° -121.158298 °	37.584200 ° -121.158298 °	16
DWR ID: DWR_RD2092_01_s_2012_16										
26	2.13	2.13	Earthen Levee	Animal Control	LS	C Ma	A3 : No rodents visible, but rodent burrows visible; need to backfill and compact or grout burrows.	37.584004 ° -121.157831 °	37.584004 ° -121.157831 °	17

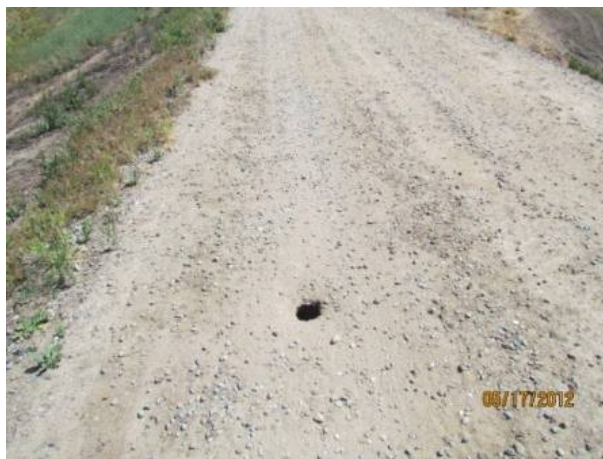
Levee Mile Report Line	27
Start Levee Mile	2.41
End Levee Mile	2.41
Location	Crown
Category	Earthen Levee
Item	Animal Control

A rodent hole was found on the crown of the levee looking downstream.

DWR ID: DWR_RD2092_01_s_2012_17										
27	2.41	2.41	Earthen Levee	Animal Control	CR	M Ma	A3 : No rodents visible, but rodent burrows visible; need to backfill and compact or grout burrows.	37.580856 ° -121.156444 °	37.580856 ° -121.156444 °	21 Y
DWR ID: DWR_RD2092_01_s_2012_21										
28	2.41	2.41	Earthen Levee	Animal Control	LS	M Ma	A3 : No rodents visible, but rodent burrows visible; need to backfill and compact or grout burrows.	37.580851 ° -121.156438 °	37.580851 ° -121.156438 °	28 Y
DWR ID: DWR_RD2092_01_s_2012_28										
29	2.42	2.42	Earthen Levee	Animal Control	LS	M Ma	A3 : No rodents visible, but rodent burrows visible; need to backfill and compact or grout burrows.	37.580441 ° -121.156758 °	37.580441 ° -121.156758 °	14 Y
DWR ID: DWR_RD2092_01_s_2012_14

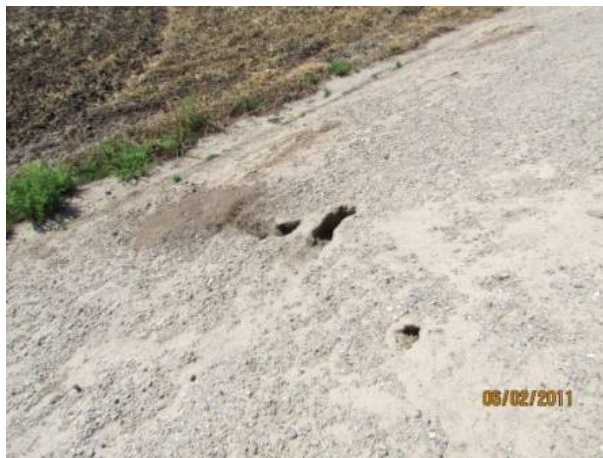
Levee Mile Report Line	28
Start Levee Mile	2.41
End Levee Mile	2.41
Location	Land Side
Category	Earthen Levee
Item	Animal Control

Rodent holes were found on the landside slope of the levee. The picture was taken from the crown looking upstream.

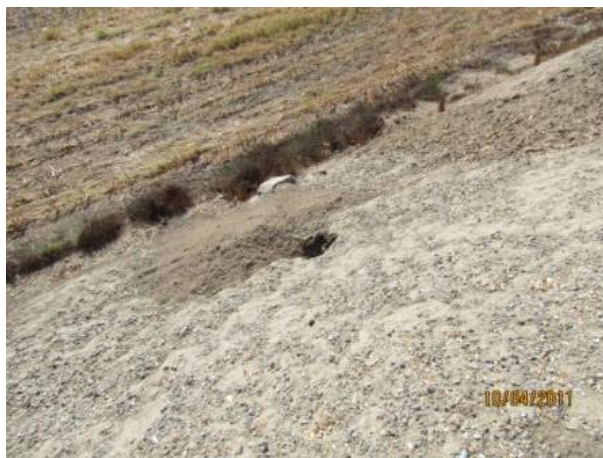
Levee Mile Report Line	28
Start Levee Mile	2.41
End Levee Mile	2.41
Location	Land Side
Category	Earthen Levee
Item	Animal Control

Updated picture of rodent hole on the landside of the levee looking upstream during fall 2011 inspection.

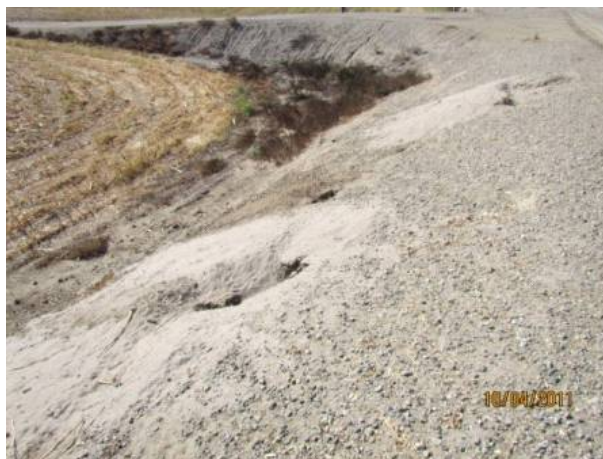
Levee Mile Report Line	29
Start Levee Mile	2.42
End Levee Mile	2.42
Location	Land Side
Category	Earthen Levee
Item	Animal Control

Rodent holes were found on the landside slope of the levee looking upstream.

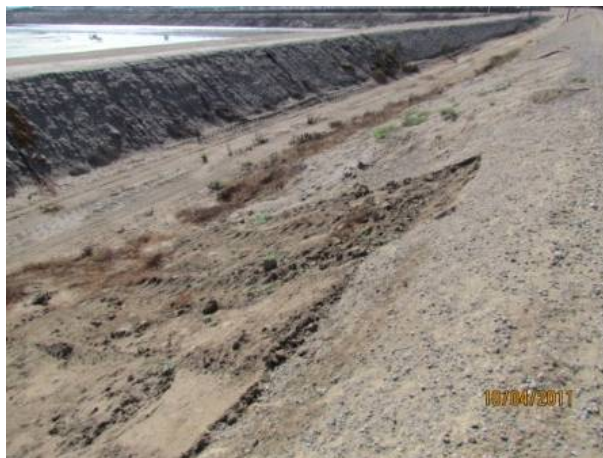
Levee Mile Report Line	30
Start Levee Mile	2.67
End Levee Mile	2.67
Location	Land Side
Category	Earthen Levee
Item	Slope Stability

Slope instability was found on the landside slope of the levee. The slope was also damaged by a vehicle. The picture was taken from the crown looking upstream.

LMR No.	Levee Mile		Category	Item	Location *	Rating ** +	Action/Comment	GPS Latitude/Longitude		Issue No. Photo
	Start	End						Start	End	
30	2.67	2.67	Earthen Levee	Slope Stability	LS	M Ma	S1 : Repair slope instability.	37.577214 ° -121.157151 °	37.577214 ° -121.157151 °	19 Y
DWR ID: DWR_RD2092_01_s_2012_19										
31	2.73	2.73	Earthen Levee	Slope Stability	LS	M Ma	S3 : Repair the levee slope damaged by vehicle traffic and prevent access where possible.	37.576336 ° -121.157217 °	37.576336 ° -121.157217 °	30 Y
DWR ID: DWR_RD2092_01_s_2012_30										
32	2.76	2.76	Earthen Levee	Slope Stability	WS	M Ma	S1 : Repair slope instability.	37.575946 ° -121.157230 °	37.575946 ° -121.157230 °	33 Y
DWR ID: DWR_RD2092_01_s_2012_33										
33	2.84	3.09	Earthen Levee	Encroachments	LS	M En	FE : Fences Inspector Comments: Barbed wire fence on landward slope.	37.574973 ° -121.156647 °	37.574001 ° -121.152183 °	972 Y

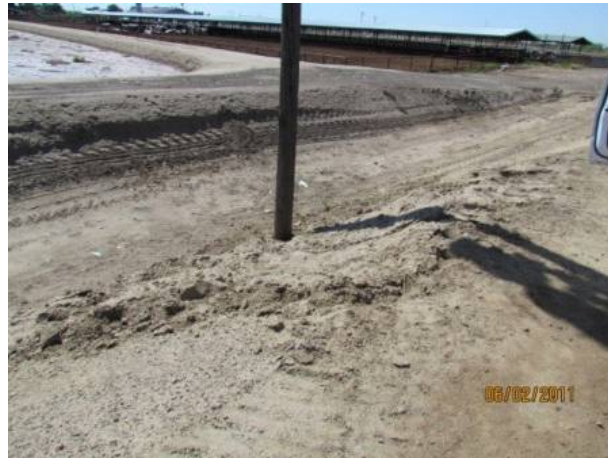
Levee Mile Report Line	31
Start Levee Mile	2.73
End Levee Mile	2.73
Location	Land Side
Category	Earthen Levee
Item	Slope Stability

Slope instability was found on the landside of the levee looking upstream.

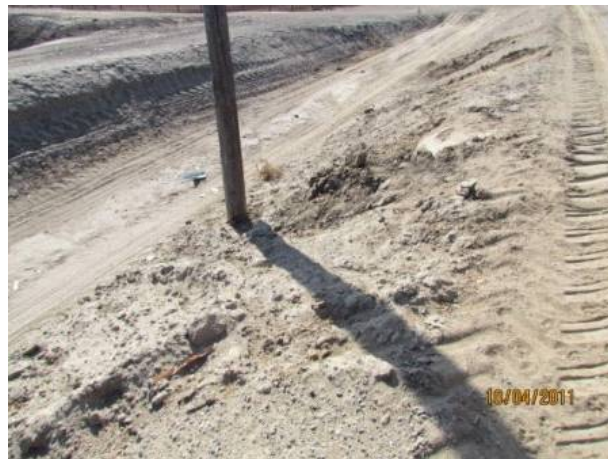
Levee Mile Report Line	31
Start Levee Mile	2.73
End Levee Mile	2.73
Location	Land Side
Category	Earthen Levee
Item	Slope Stability

Updates picture of the slope instability on the landside of the levee looking upstream.

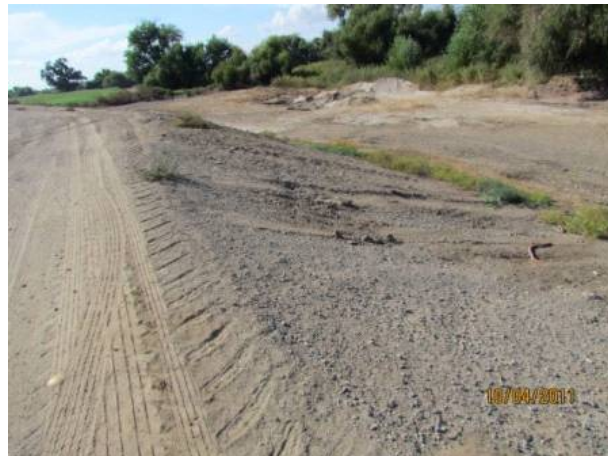
Levee Mile Report Line	32
Start Levee Mile	2.76
End Levee Mile	2.76
Location	Water Side
Category	Earthen Levee
Item	Slope Stability

Slope instability was found on the waterside of the levee looking upstream.

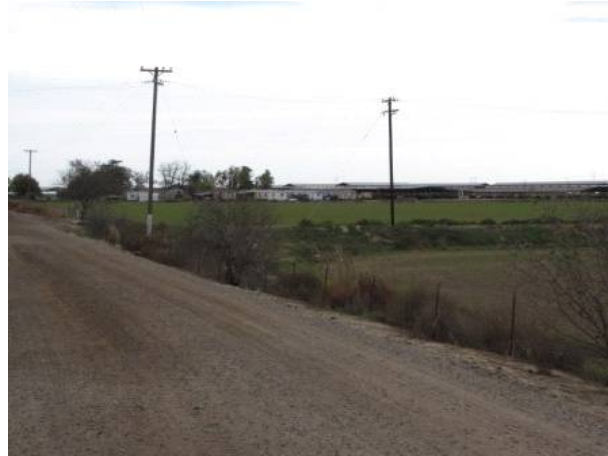
Levee Mile Report Line	33
Start Levee Mile	2.84
End Levee Mile	3.09
Location	Land Side
Category	Earthen Levee
Item	Encroachments

View of barbed wire fence along the waterward slope looking upstream.
